# Manhole Inspection Summary

Manhole # S61G\_\_014MH

Insp Date: **3/28/08 9:20 AM**

**Location** Address: **333 Cassell Dr.**

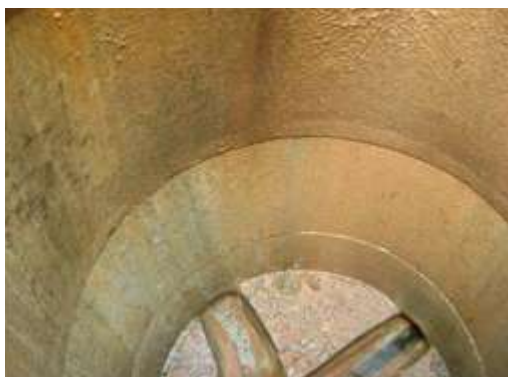
Defect 3

Infiltration: ☐ None ☒ **Joint** ☐ Cracks ☐ Mortar ☐ Roots ☐ Wall

Infiltration on barrel wall

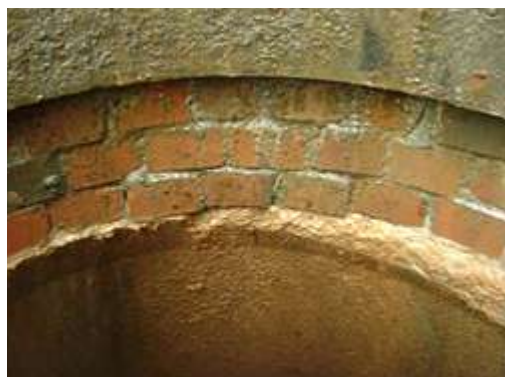
Defect 1

Condition: ☐ Sound ☐ Cracked ☐ Root Intrusion ☒ **Loose Brick** ☒ **Deteriorated**

Infiltration: ☐ None ☒ **Joint** ☐ Cracks ☒ **Mortar** ☐ Roots ☐ Wall

Infiltration under frame adjustment

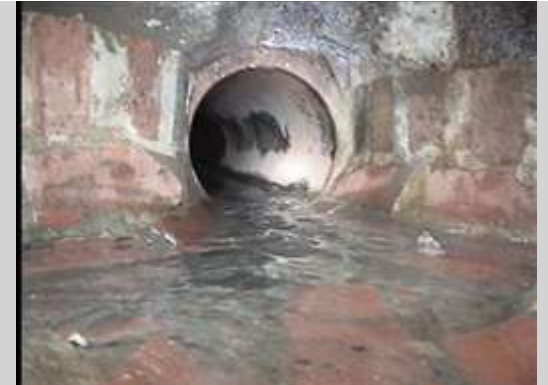
12 O'Clock Outflow

Pipe Height: **8.4** (in.) Rod and Bar (Angled)  
Pipe Material: **Clay** ☐ Pipe Lined  
Invert Depth: **8.54** (ft.) Flow Characteristics: **Fast**  
Deposits: ☒ None ☐ Mud ☐ Sludge ☐ Debris ☐ Grease  
Silt Depth: (in.) Deposits Extent:  
Infiltration: **None** Pipe Seal Cond: **Sound**

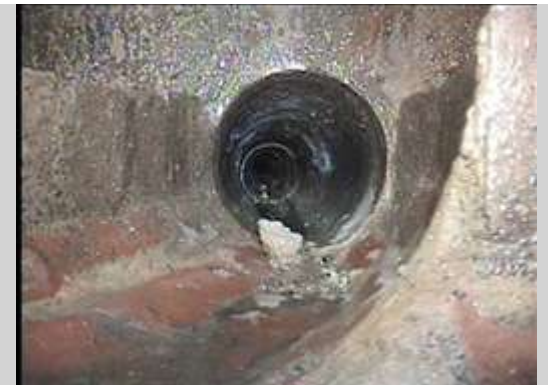
3 O'Clock Inflow

Pipe Height: **8.4** (in.) Rod and Bar (Angled)  
Pipe Material: **Clay** ☐ Pipe Lined  
Invert Depth: **8.33** (ft.) Flow Characteristics: **Slow**  
Deposits: ☒ None ☐ Mud ☐ Sludge ☐ Debris ☐ Grease  
Silt Depth: (in.) Deposits Extent:  
Infiltration: **None** Pipe Seal Cond: **Sound**

Connects To: **Dead End**

☒ Possible Illicit Connection

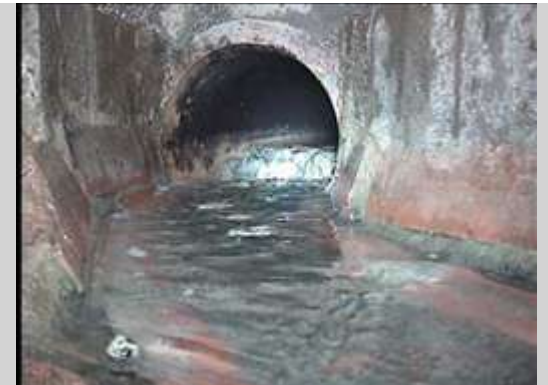
9 O'Clock Inflow

Deposits: ☐ None ☐ Mud ☐ Sludge ☒ **Debris** ☐ Grease

Silt Depth: **1** (in.) Deposits Extent: **Light**
